Hemingford Culvert Repairs

The Hemingford Culvert Repairs were carried out for Kier/TVO as part of a handover of a structure to a public Client. A previous contractor had tried to repair a water main that was laid over the existing culvert and damaged the culvert in the process. This contractor then used corrugated asbestos sheeting to repair the damage and backfilled the structure without telling the owner.

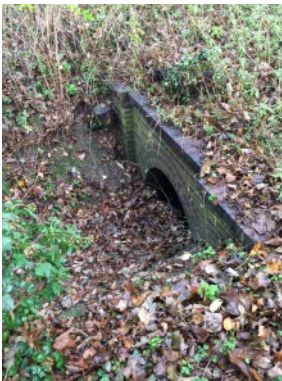
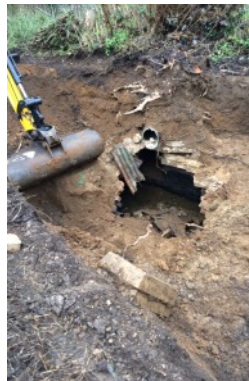
The existing culvert was overlaid by a 10" asbestos pipe and also had live fibre-optic cables running over the soffit and through the poorly repaired concrete section.

MDA asbestos awareness trained operatives carefully exposed the asbestos pipe and associated live cables and used local licensed Asbestos Removal contractors to remove the waste from site.

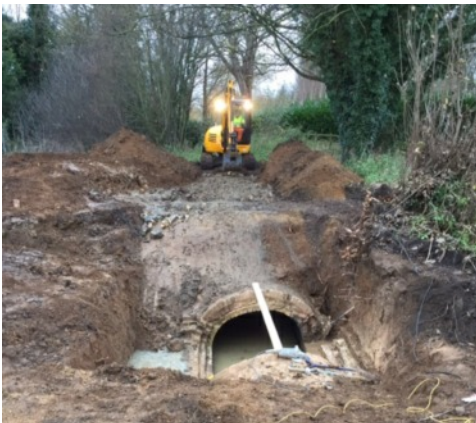
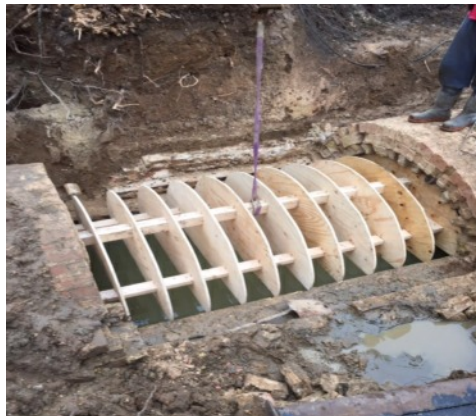
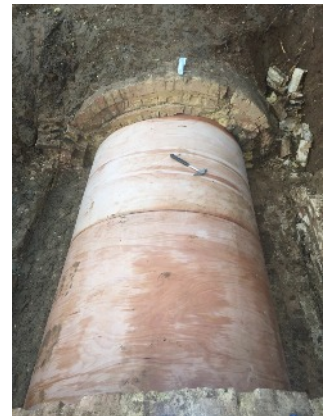
Once the water main had been removed and the live cables had been re-diverted, the works could begin to repair the culvert structure.

With the obstacles removed, MDA broke away the existing culvert until the arch was deemed structurally safe, we then formed internal and external timber shutters to match the existing soffit shape. With this completed the steel reinforcement could be tied to provide structural support and durability and the C40 concrete was poured and compacted carefully ensuring a quality finish both internally and externally.

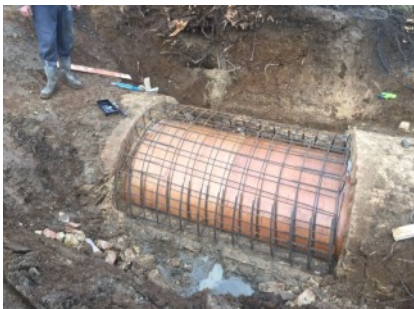
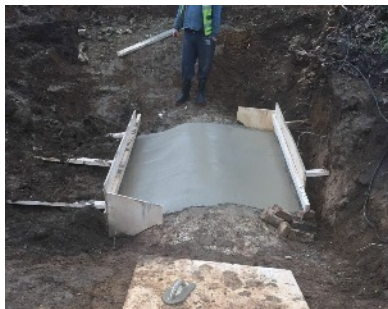
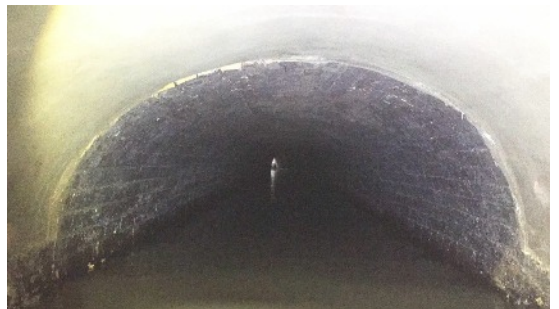
The photos above show how the concrete was poured to form the exact shape of the existing culvert which was to the great satisfaction of the Client. This project was finished off by carrying out a full internal video condition survey of the 30m long culvert which could be used in the handover documentation to the Client.
