matt durbin associates
.....engineering integrity

Cake Pill Outlet Structure Refurbishment

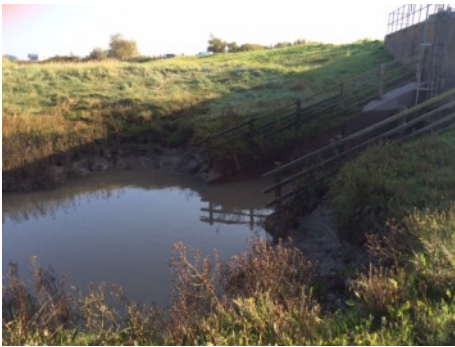
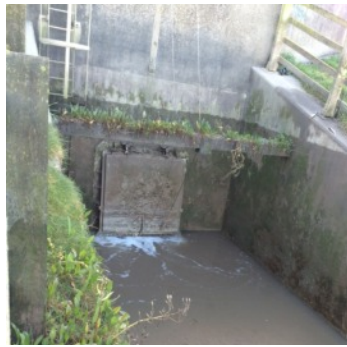
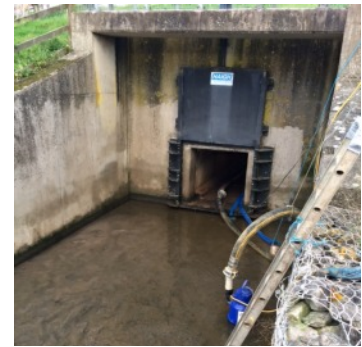
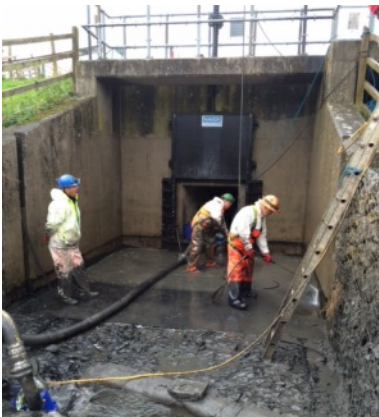
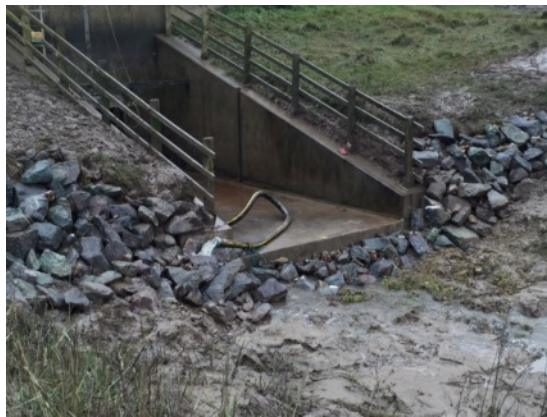
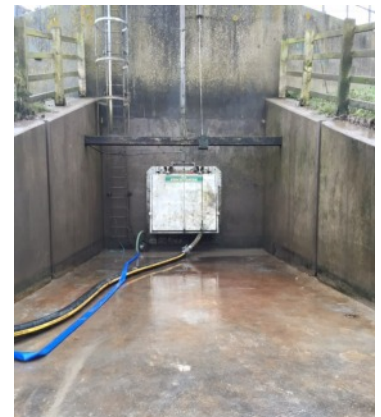
The existing tidal structure located at Cake Pill in Aust, Somerset was suffering from a severe case of scour under the reinforced concrete outfall slab. This had caused the tidal water to seep up underneath the structure and burst the joints between the precast concrete culvert sections, whilst eroding the backfill material around the culvert units. MDA completed these refurbishment works by firstly excavating in front of the outlet slab and removing the silt, then forming a RC toe beam embedded into the bedrock below. This wall then filled with 40tonnes of 300-500mm granite rock armour to protect the structure and surrounding wing-walls.

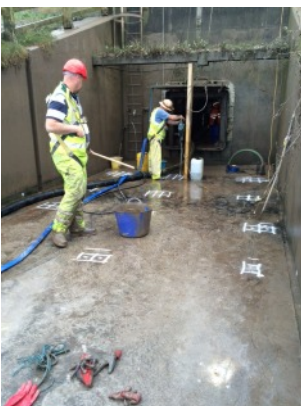
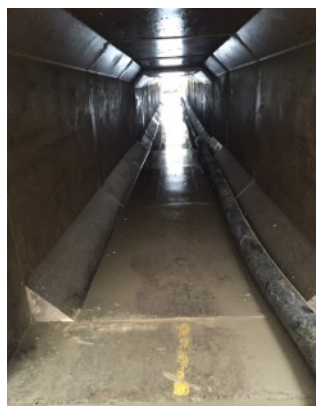
Once the curtain wall was formed at the outlet end, a series of 50mm diameter core holes were drilled through the structure at 1m centres and grout was pressure pumped into these holes systematically from inlet to outlet to fill any voids around the structure. This process could be easily monitored by drilling air holes ahead of the grout holes to check that the structure was being fill up evenly. This can be seen in the photos below.

The photos on the left show the setting out and drilling of the core holes through the existing RC slab, and the cleaning of the existing culvert.

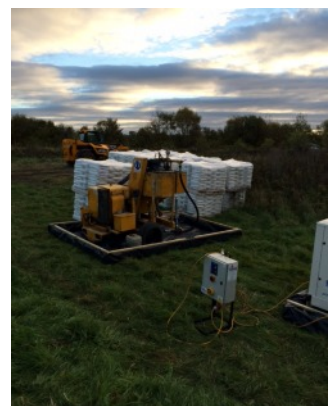
The photo on the right is an example of MDA's commitment to the environment and ensuring we are exceeding environmental expectations.
