EA Cheltenham - Flood Alleviation Scheme

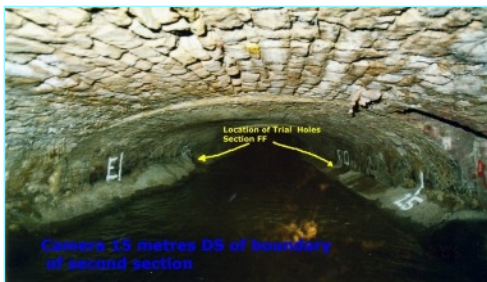
← The existing culvert was no longer capable of sustaining the loads being subjected to it and an immediate repair solution was required.

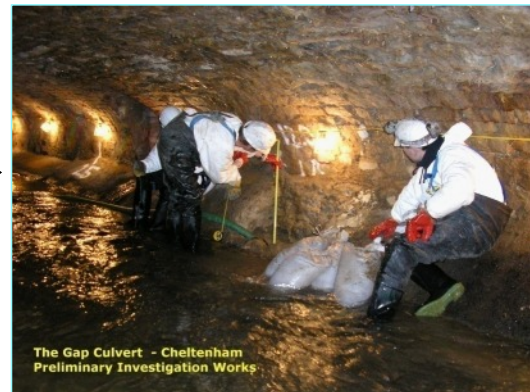
Investigation works were undertaken to determine the condition of the culvert. Trial holes were undertaken to determine the safe ground bearing foundation loads.

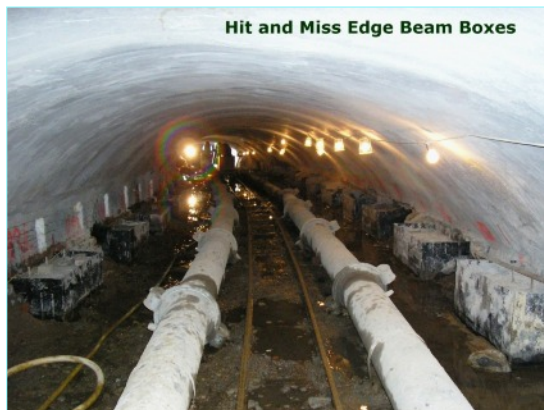
Upon completion of the initial survey, hit and miss edge beam boxes were installed within the culvert to form the strength for the new arch.

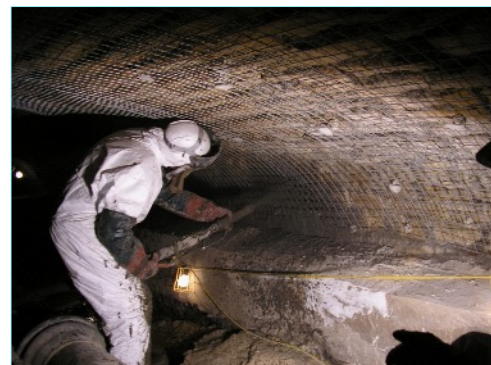
Upon completion of the new foundation installation, structural mesh was pinned to the culvert and the sprayed concrete was applied throughout the length of the culvert.

The floor slab was then poured between the two edge beams to ensure that the newly reinforced culvert was completely structurally sound. This project was completed on time and within budget and was completed without accident or incident.
