Gainsborough Hotel Timber Heading

The Gainsborough Hotel in Bath has recently been renovated and is due to be opened in Autumn 2015. The current foul discharge from the building was located behind a basement wall and discharged into the mainline culvert running through Bath City Centre. This discharge pipework needed to be up sized due to the new use of the building but could not be accessed without installing a timber heading.

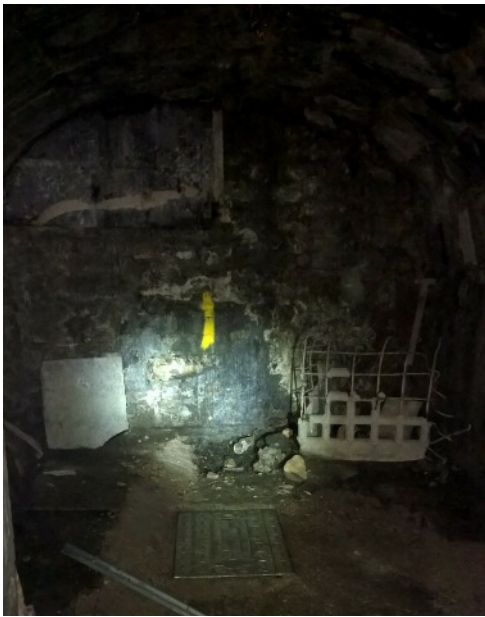
The foul water discharge pipework was 2m behind the concrete wall that can be seen in the photo to the left. The maintenance manhole can also be seen within the photo.

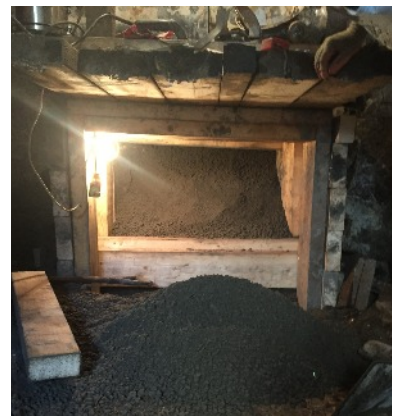
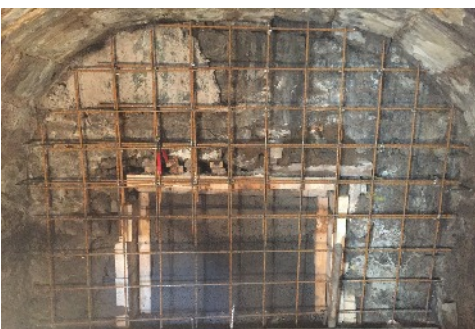
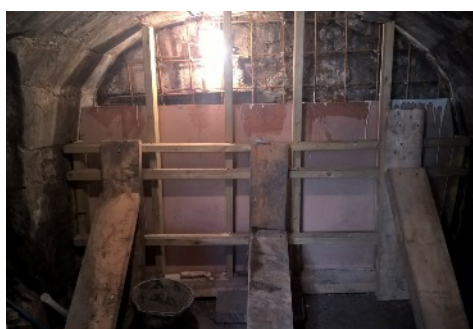
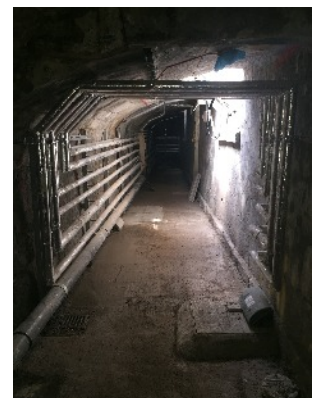
Once the pipework was exposed, and the up-sized connection was made, the pipework could be backfilled. The heading was then backfilled by dry-packing it with concrete and then casting a RC wall to the existing basement wall. MDA completed the works by installing a concrete screed over the basement floor to ensure there could be no trip hazards for maintenance personnel.
