Lyewater – Shaft and Timber Heading Works

The Lyewater Shaft and Timber Heading was carried out in Crewkerne in 2014 for Client Team Van Oord/Kier MG Ltd. This was again installed in the back garden of a residential property where access and egress was very limited. The existing culvert had collapsed underneath a residential property and creating a new access shaft and timber heading was the only way to access and repair the collapsed culvert. The photos below show the key stages of the scheme.

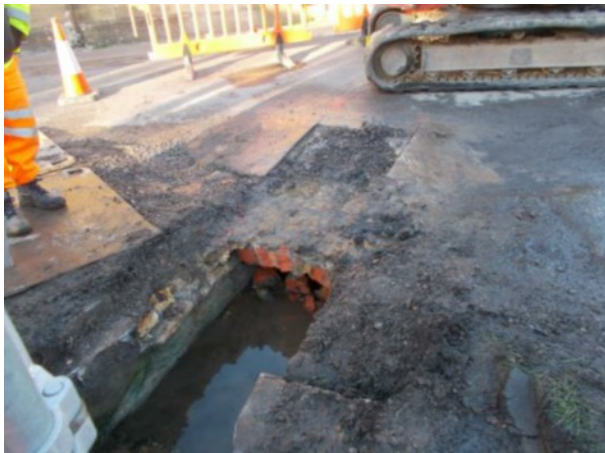
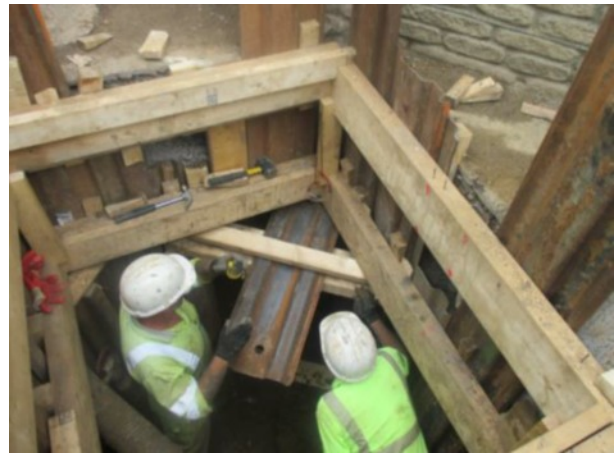
The inlet of the small culvert gave the Team Van Oord/Kier MG the indication that there was a problem within the culvert as the water kept backing up and flooding the road. Due to the size of the culvert, man entry was not possible so a CCTV unit had to survey the culvert and a collapse was found.

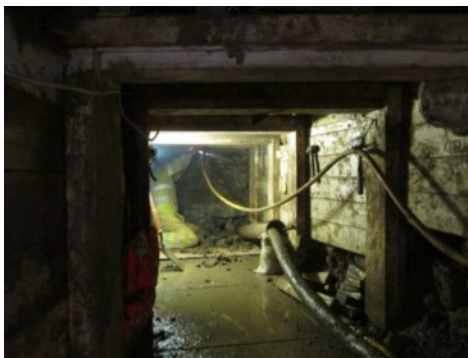
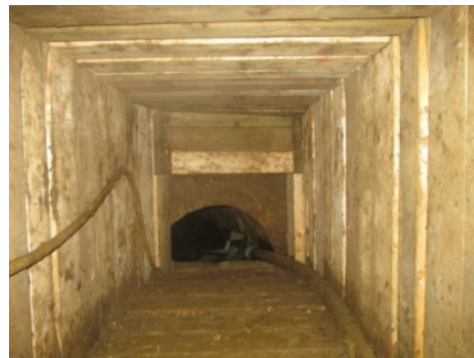
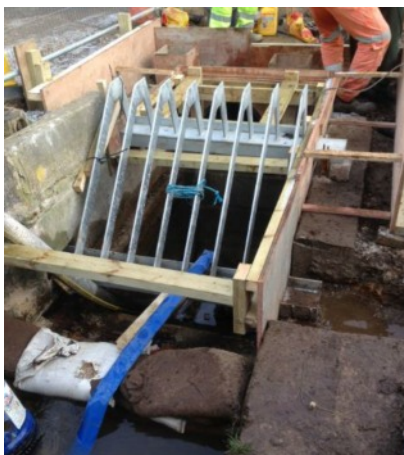
The photos above show the timber heading and how it changed direction to follow the existing culvert. The timber heading was designed to withstand the loading from the property above and again installed with care and accuracy.
