North Queensferry - Culvert Lining

The main 1500mm diameter brick trunk main to the Forth Road Bridge Crossing was to be relined, and on a presurvey, a major structural collapse had occurred. This had caused the sewer to be vertically displaced by 500mm. As this was 20m below ground level, access had to be via a shaft onto the culvert itself. The key stages of this huge engineering feat of a project are shown below.

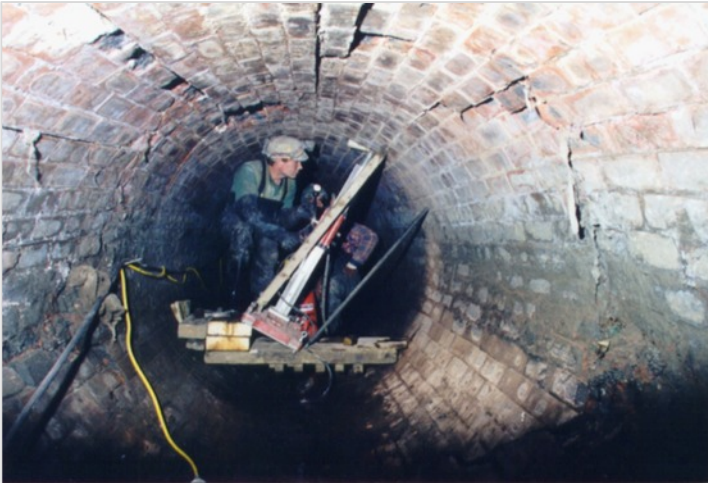
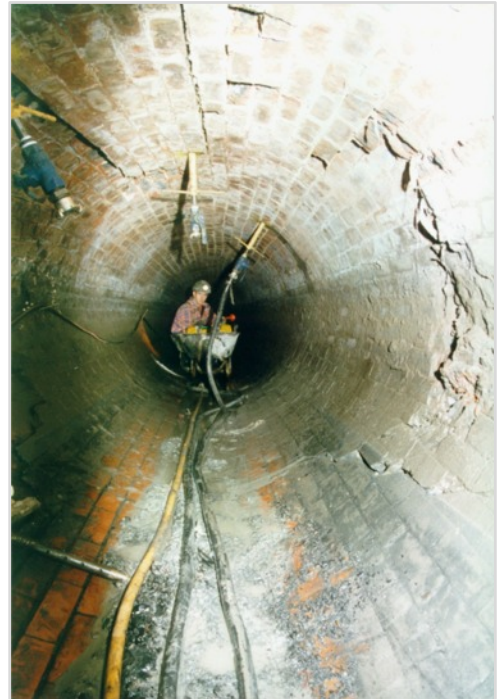
The existing condition of the culvert can be seen within these photos. Due to the structural condition, it was imperative to create a safety zone around the brick sewer. This was completed by drilling and injecting grout at 1m centres throughout the archway until refusal.
