Otter St Mary - Flood Alleviation Scheme

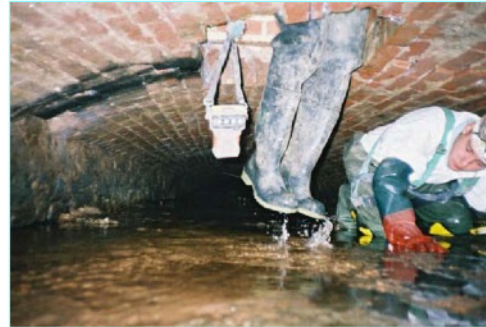
This photo shows the current condition of the culvert, its original internal dimensions are only 600mm high at the crown by 1200mm wide. It can be seen that the working conditions are extremely tight and these conditions are something that Matt Durbin Associates specialise in.

The Otter St Mary Flood Alleviation Scheme had issues with flooding due to the main culvert running through the town not having the capacity to cope with storm conditions. The culvert was very shallow and the existing capacity needed to be trebled. The size of the culvert also needed to be enlarged to meet the modern highway loading requirements.

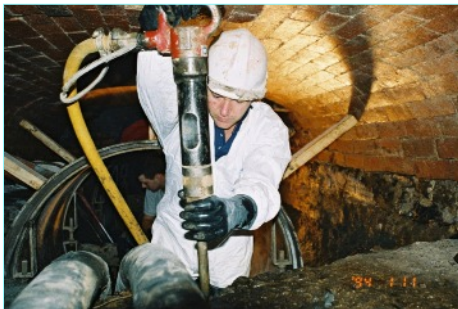
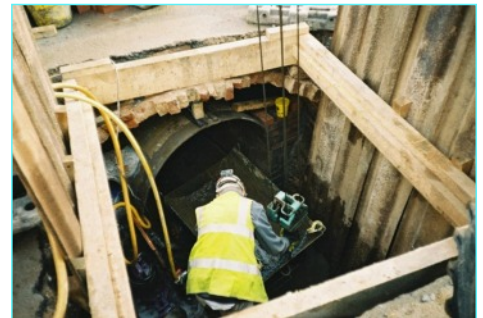
The photo on the left shows one of the first stages of the works whereby MDA had to lower the invert of the culvert by 800mm to gain the required capacity. The spoil was removed to a licensed tip using a mini crane accessing the culvert from a purpose built access shaft shown on the right.

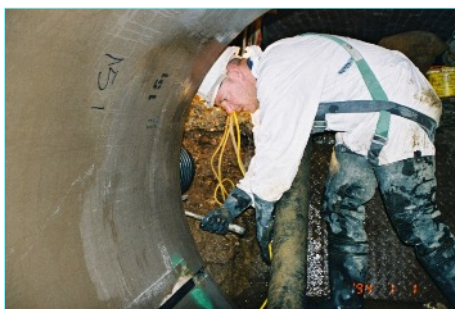
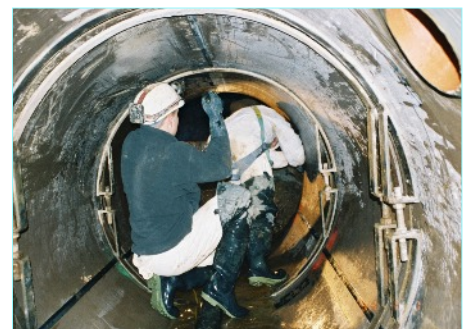
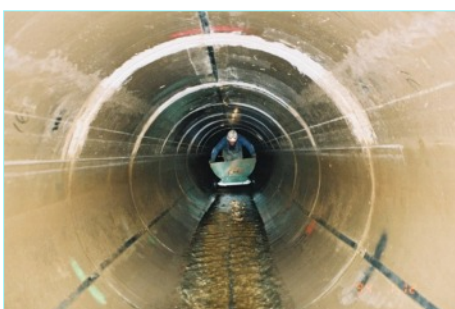
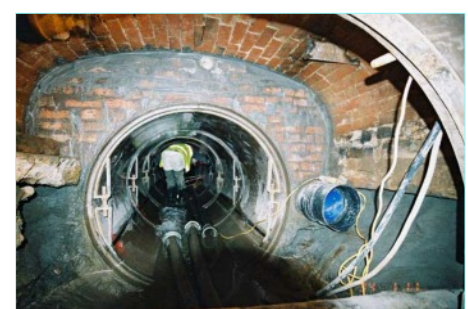
The photos below show each of the final stages of work (top left) the annulus of the liner being trimmed for the designed thickness of grout. The (top right) photo shows the connections being installed immediately after the next section of liner was installed. The bottom photos show the finished product.
