Radstock Shaft & Lining Works

The Radstock works comprised of 600m of pipeline renovation that was split into two separate elements of work. An existing pipeline ran underneath several businesses and properties and was in need of repair. The first 200 meters of the pipeline could be accessed through an existing manhole, however two new shafts had to be built to gain access to the remaining 400m of the pipeline.

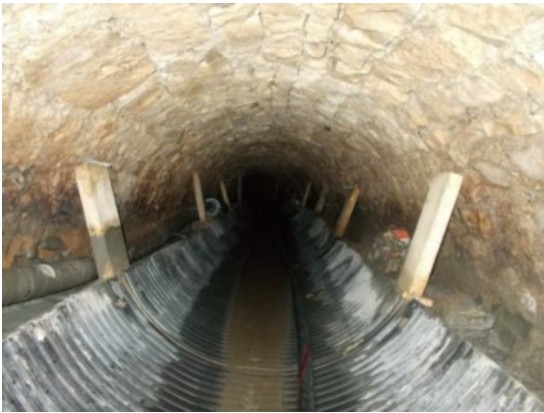
The photo above on the left shows the masonry arch culvert being prepared for the sprayed concrete lining while the photo on the right shows the completed works

The first 200m of pipeline was being cleaned and prepared for the combination of a plastic half channel solution. During this time the two additional shafts were being constructed. Photos of these elements can be seen below.

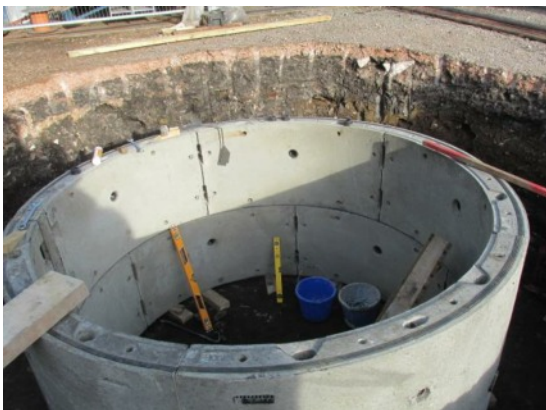
These two photos show the 2.4m internal diameter segmental shaft ready to have the ring beam poured with concrete and at completion, 8m deep onto the culvert.

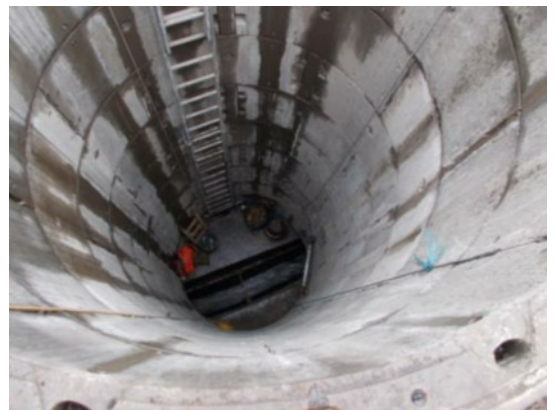
The photo on the right shows another access shaft but this is a temporary shaft and is only 3m deep. This uses sheetpiles and heavy timber waling beams.

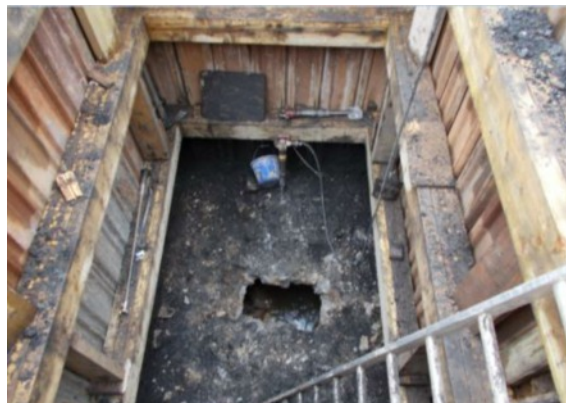
This shaft shown on the left has been excavated to 2m wide by 3m long internally to give the required working room to facilitate the final 200m of concrete sprayed lining.
