Chyandour Culvert Remedials

Chyandour Culvert remedial works were completed by MDA for Maygurney/Kier in 2012. The small culvert in Penzance, Cornwall was suffering heavily from a lack of maintenance and was in need of repair before the culvert collapsed completely stopping the flow of water through it. Below are a small selection of photos showing our works on the scheme.

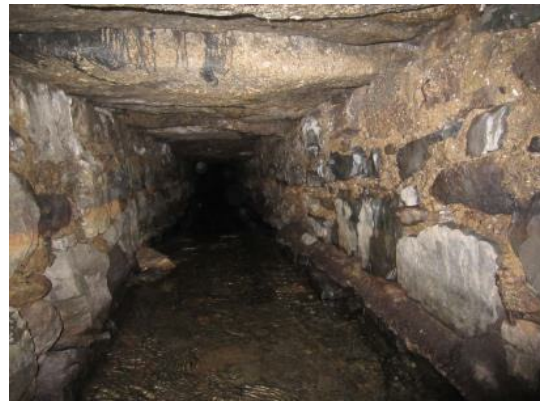
This photo shows the current condition of the culvert, its original internal dimensions are 600mm wide by 900mm deep. Due to deposits at the invert the usable depth of the culvert was only 600mm which was being exceeded during heavy rainfall. MDA removed the deposits by hand to restore the full cross sectional area and then carried out repairs throughout the culvert.

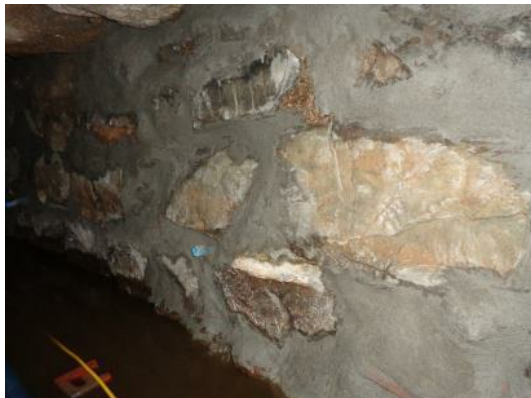
The photo on the left shows a close up of the repair works that MDA carried out. Over the years, much of the masonry walling had fallen out of the culvert, blocking the channel and causing the build up of debris. These stones were replaced in their original position within the wall and re-pointed. MDA replaced all loose stones and re-pointed the entire culvert.

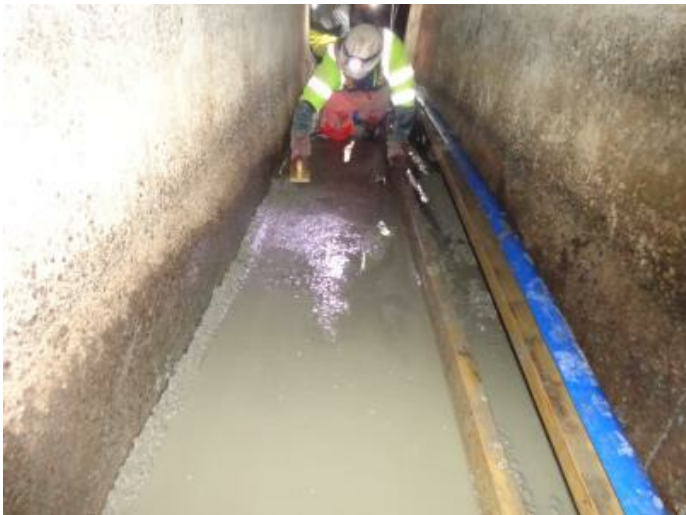
The photos below on the left shows the repaired culvert having a new reinforced concrete floor installed. This not only strengthens the existing culvert but allows the free flow of water downstream through the culvert without obstacles. The photo at the bottom right shows the completed works restoring the existing culvert to its original use.
