### Environment Agency Culvert Remediation

The following document shows several different culvert remediation schemes that MDA have completed for the environment agency over the past 5 years. Each scheme involves differing techniques and each has its own difficulties. Most of these schemes are logistically difficult to access and are in close proximity to neighbours and/or local businesses. MDA specialise in carrying out these types of projects and we thrive on delivering the Client's specification no matter how difficult the task is!!

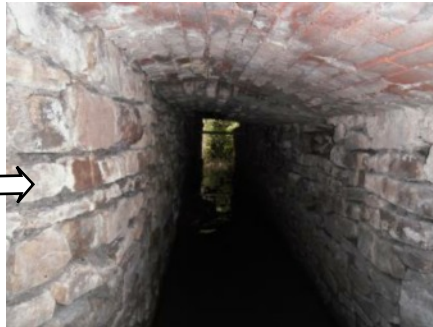
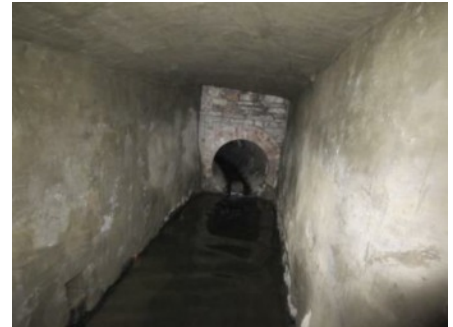
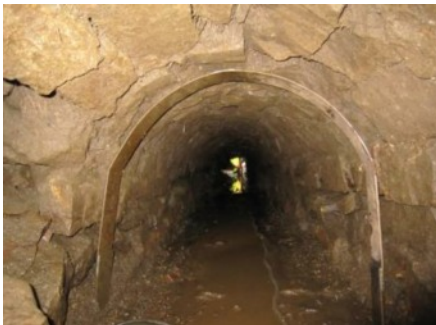
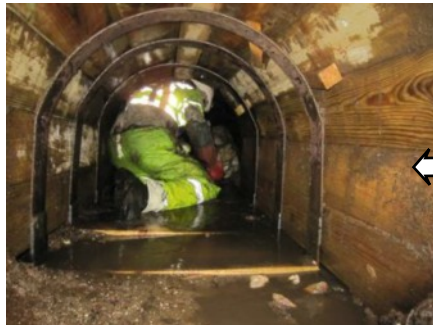
Recent cctv survey inspection of this 30m long culvert showed that it was deteriorating and was in need of repair. MDA removed obstacles by hand and re-pointed and replaced damaged bricks within the culvert.

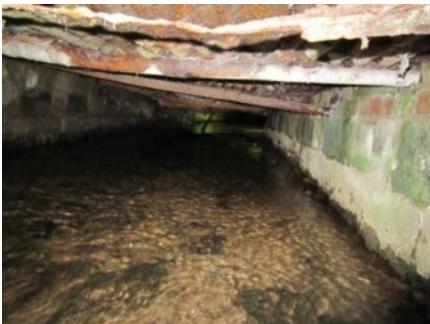
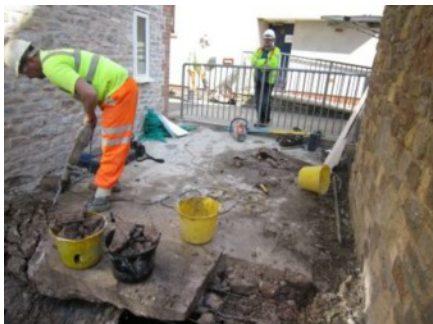
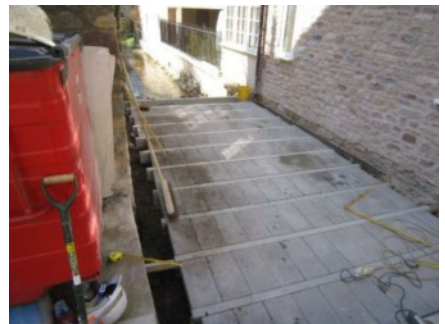
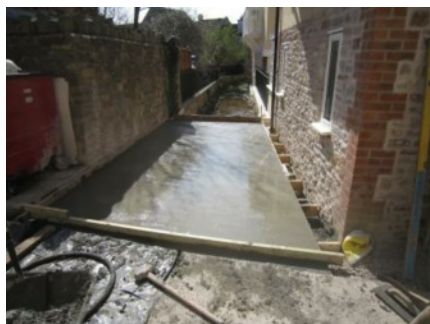
### Survey of existing outlet slab, followed by Demolition and Installation of a new RC Outlet Structure

An arched culvert underneath a road bridge was collapsing and needed to be supported. MDA operatives installed a designed steel frame at 500mm centres then drove timber headboards to protect themselves and to support the arch prior to lining the culvert.

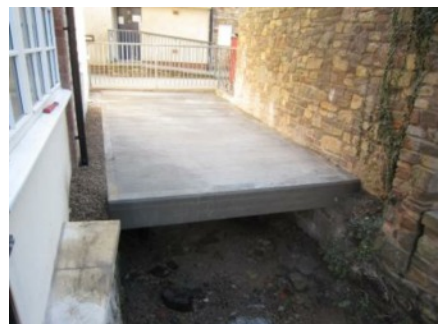
The existing concrete outlet slab spanning between two properties was failing and could not be trafficked. MDA demolished the existing slab and replaced it with a new block and beam structure with an overlying RC slab. The EA commended us on the works and were very pleased with the final product.
